Old Fort Lewis Campus Infrastructure Assessment and Report

APRIL 25, 2011

Old Fort Lewis Campus Infrastructure Assessment & Report

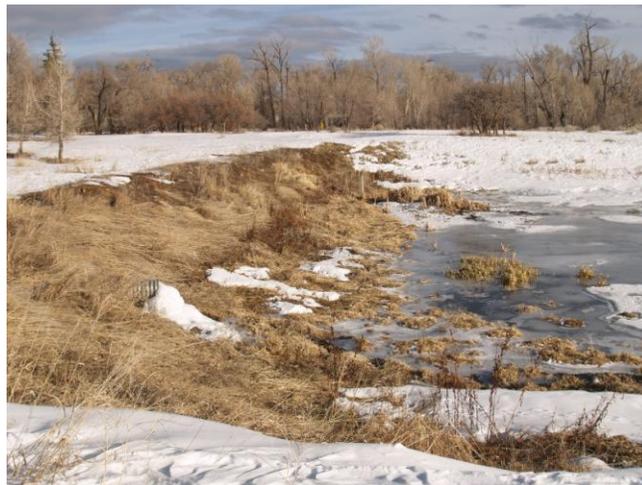
It is apparent the treatment system was designed for flows well in excess of what has existed since the facility was completed. The system was designed with a clay soil liner to contain the sewage effluent and provide a seal between the wastewater lagoon system and the underlying granular soils. However, over the years, the previous facility manager, Tom Campion, has informed us that the system has failed to maintain a reasonable liquid volume as purportedly designed. Additional water has been transferred to the lagoon system on occasions to attempt to fill the lagoon to a desired design level. This has been unattainable as reported by Mr. Campion.

During the current site visit, an existing culvert diverts ditch water into the lagoon in addition to the sewage flow. Based upon our observations, the system holds relatively little water thus confirming the comments from Mr. Campion about the liner integrity.

For any sewage system constructed under the requirements of the CDPHE, a liner must demonstrate the ability to have a permeability of less than 1/32 inch per day. This system cannot meet this requirement as presently constructed.

Wastewater Facility – Note
Culvert in foreground diverting
irrigation water into lagoon.

Remedial work is recommended for the wastewater treatment system to comply with the current regulations of the health department having current jurisdiction. It appears this system initially was sized to be a system regulated by the CDPHE. No discharge monitoring report would have been required since it was designed as an evaporation type of facility. To date no data is available to determine if the system is currently listed with the CDPHE.

The non-discharging waste stabilization lagoon system is oversized for the current and prior campus use. It is recommended to attempt to locate the design data for the original design. This would assist in future planning to determine if this type of system should remain as designed.

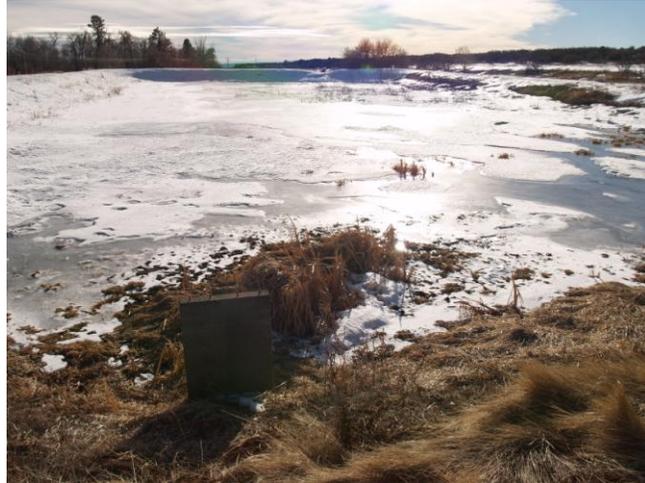
Sewer outfall pipe beyond
Concrete catwalk support
in area of cattails.

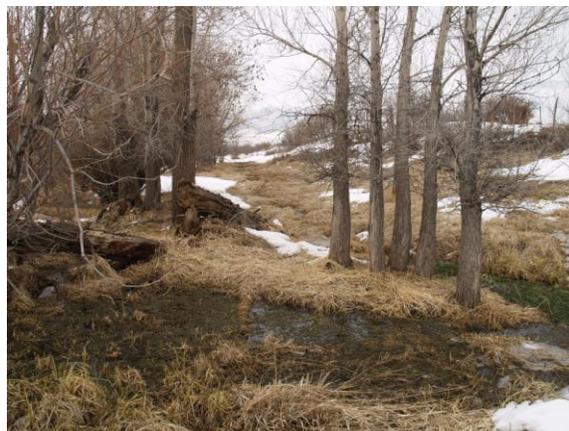
Location of spring collection access at Edge of trees. Collection system follows draw for a few hundred feet with collection pipe and upper manhole. Total length of collection system unknown.

- Re-connect the chlorination system to the water system.
- Flush and clean the infiltration gallery lines to remove sediment, roots, etc.
- Flush and disinfect the clearwell.
- Repair the clearwell float valve assembly.

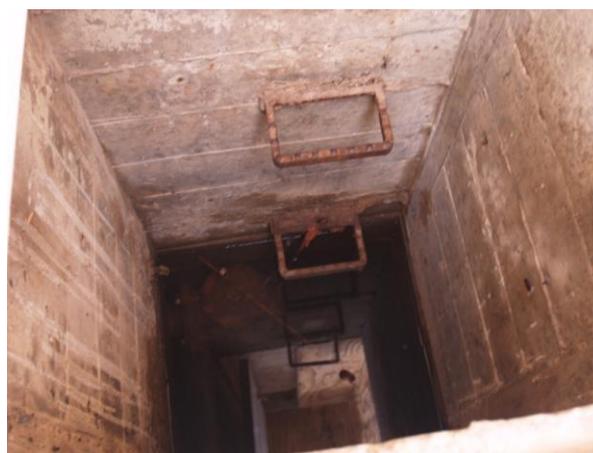
During the site visit, the chlorination system was turned off and the solution tank was empty and the suction line was not even installed in the solution tank. Due to the limited water usage, the water will remain in the cistern for quite a period of time and could stagnate. The float valve to control the level of water in the system was malfunctioning with the system valve submerged.

Clearwell with pump float well submerged.

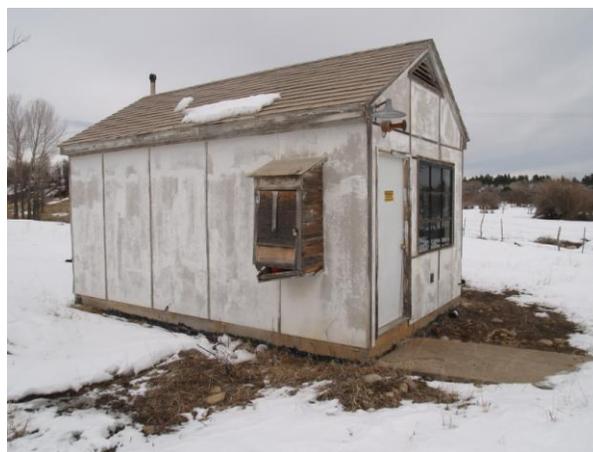
Pump house w/ pressure tank, plumbing controls, chlorination system, pressure pumps in pit, with cistern adjacent to building.

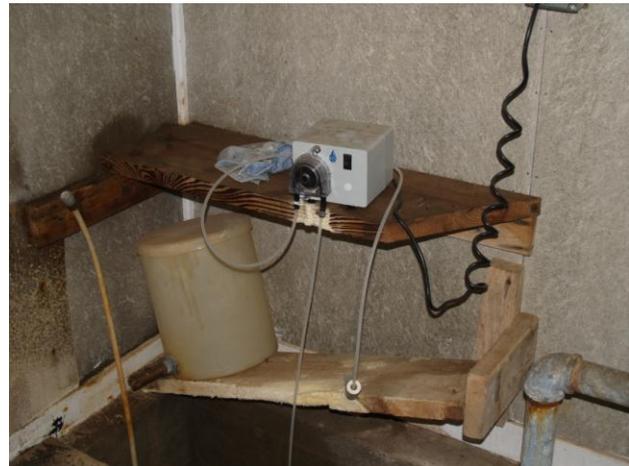
In all probability, if a water test was performed, pathogens would be present in the water. The source water is shallow and subject to contamination from wildlife and livestock. At a minimum, the chlorination system should be placed back into service and the float valve on the cistern repaired to function as designed. The entire water system should be dosed with a high level of chlorine (25 ppm minimum for 24 hours). The system should then be thoroughly flushed and there needs to be a reasonable chlorine residual in the system (0.5 to 1.0 ppm). Water samples should be obtained and tested to ensure successful disinfection. The present users should be notified that the water is not deemed safe and a boil water order should be implemented immediately.

Chlorination system in pump house.
Note the system was disconnected and
in need of repair.

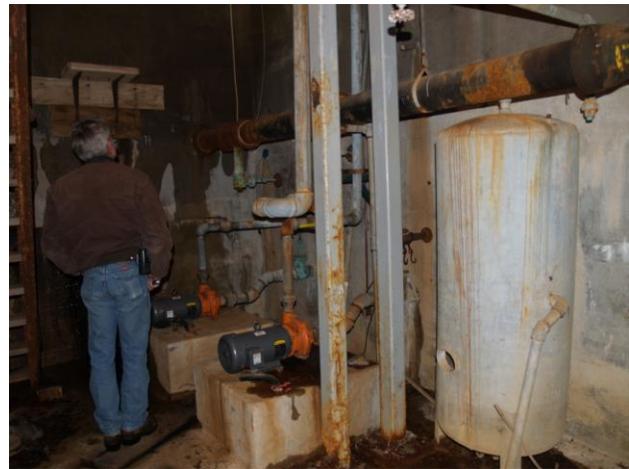
Pump house pumps – one operating, one
standby with alternating sequence. This
is located in pit below the pressure tank
system.

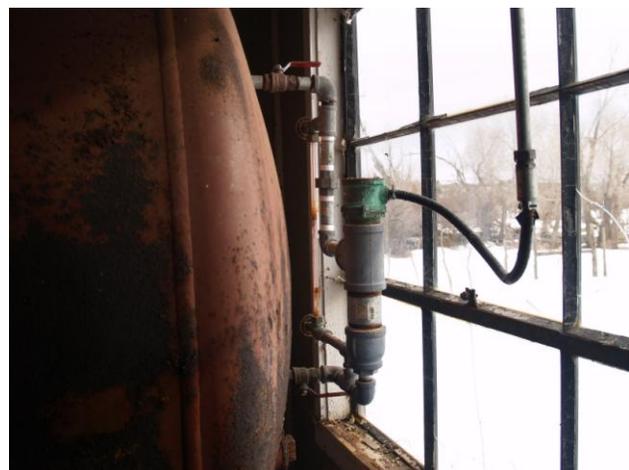
Pressure tank assembly with
pressure switch and sight gauge.

The potable water distribution system is pressurized at the water pump house via an hydropneumatic tank system to maintain pressures within the 40 to 60 psi range for the campus buildings. This pressure is standard and normal for 'in house' use. All irrigation water outside the buildings is via a separate irrigation system as noted below.

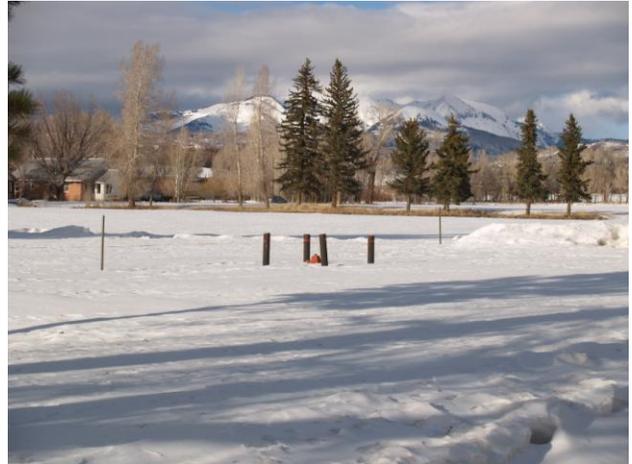
results have determined that the maximum fire flow available at each hydrant is approximately 500 gpm with a 20 psi residual pressure. Refer to Figure 2 and the calculations included in the Appendix. This matches what was reported to be the general flow available from Mr. Campion during prior flow tests. Steve Ebner, Fire Chief of the Fort Lewis Mesa Fire Protection District was contacted to discuss his knowledge of the campus system. He told us that he has routinely used the campus system for training purposes. As recently as last year, his staff did operate and flush each hydrant on the campus during a training exercise. From the training operations, he feels that with drafting capabilities on the fire trucks, he can deliver upwards of 800 gpm from the hydrant system. Additionally, the department has dedicated transfer trucks for transporting water from the river and other ponds and reservoirs to assist with a fire. With this additional method of water delivery, a total fire flow of approximately 1,500 gallons/minute is possible. The district fully supports fire sprinklers for any building improvements and modifications. Based upon this information, our hydraulic model is deemed conservative and actual flows may be higher.

Typical Fire Hydrant Assembly with protective bollards. Please note access to the hydrants is not provided.

- Locate all valves. Operate (exercise) valves.
- Pothole lines to determine type of pipe installed and exterior condition of pipes.
- Determine how the pipe intake is conctructed at the reservoir. Based upon findings, remedial work may be warranted to keep debris out of the pipes that may cause problems at hydrants, valves, fittings, etc.
- Verify flow and pressure at each fire hydrant.
- Operate individual yard hydrants to determine condition. Repair/replace as warranted.
- Determine the seasonal operation level of the reservoir and fire flow volumes available for each month of the year.

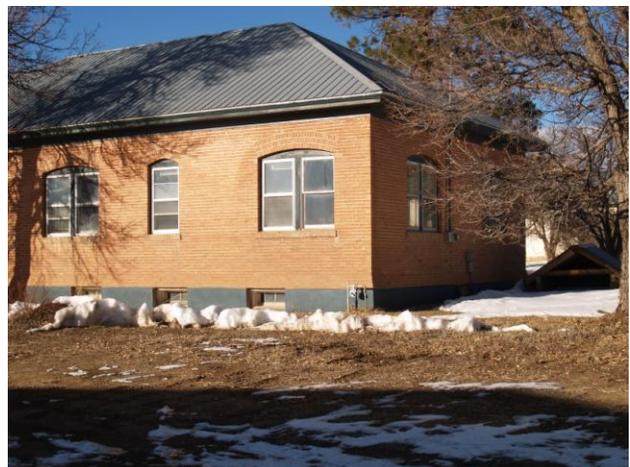
Typical Gas Service Connection with pressure regulator visible.

The gas services do have pressure regulators and appropriate shut off valves located at each building exterior prior to the service line entering the building.

- Locate all valves. Operate (exercise) valves. Lubricate as necessary.
- Pothe lines to determine type of pipe installed and exterior condition of pipes.
- Pothe to locate the anodes installed for cathodic protection. Determine condition of anodes and replace if warranted.
- Determine status of service lines to all buildings and where buildings have been removed after the system has been installed. Verify all abandoned service lines are properly capped and marked. Some buildings that were shown in 1984 have been subsequently removed.
- Verify gas pressures in system to ensure proper flow and pressure are available for equipment utilizing the gas.
- Provide pipe to soil potential readings.
- Perform regulator maintenance.
- Provide leak detection survey to confirm system integrity.
